**WILLIAMS LAKE CONSERVATION COMPANY**

**WILLIAMS LAKE DAM  
EVALUATION**

**MARCH 2005**

**Re: Williams Lake Dam Evaluation**

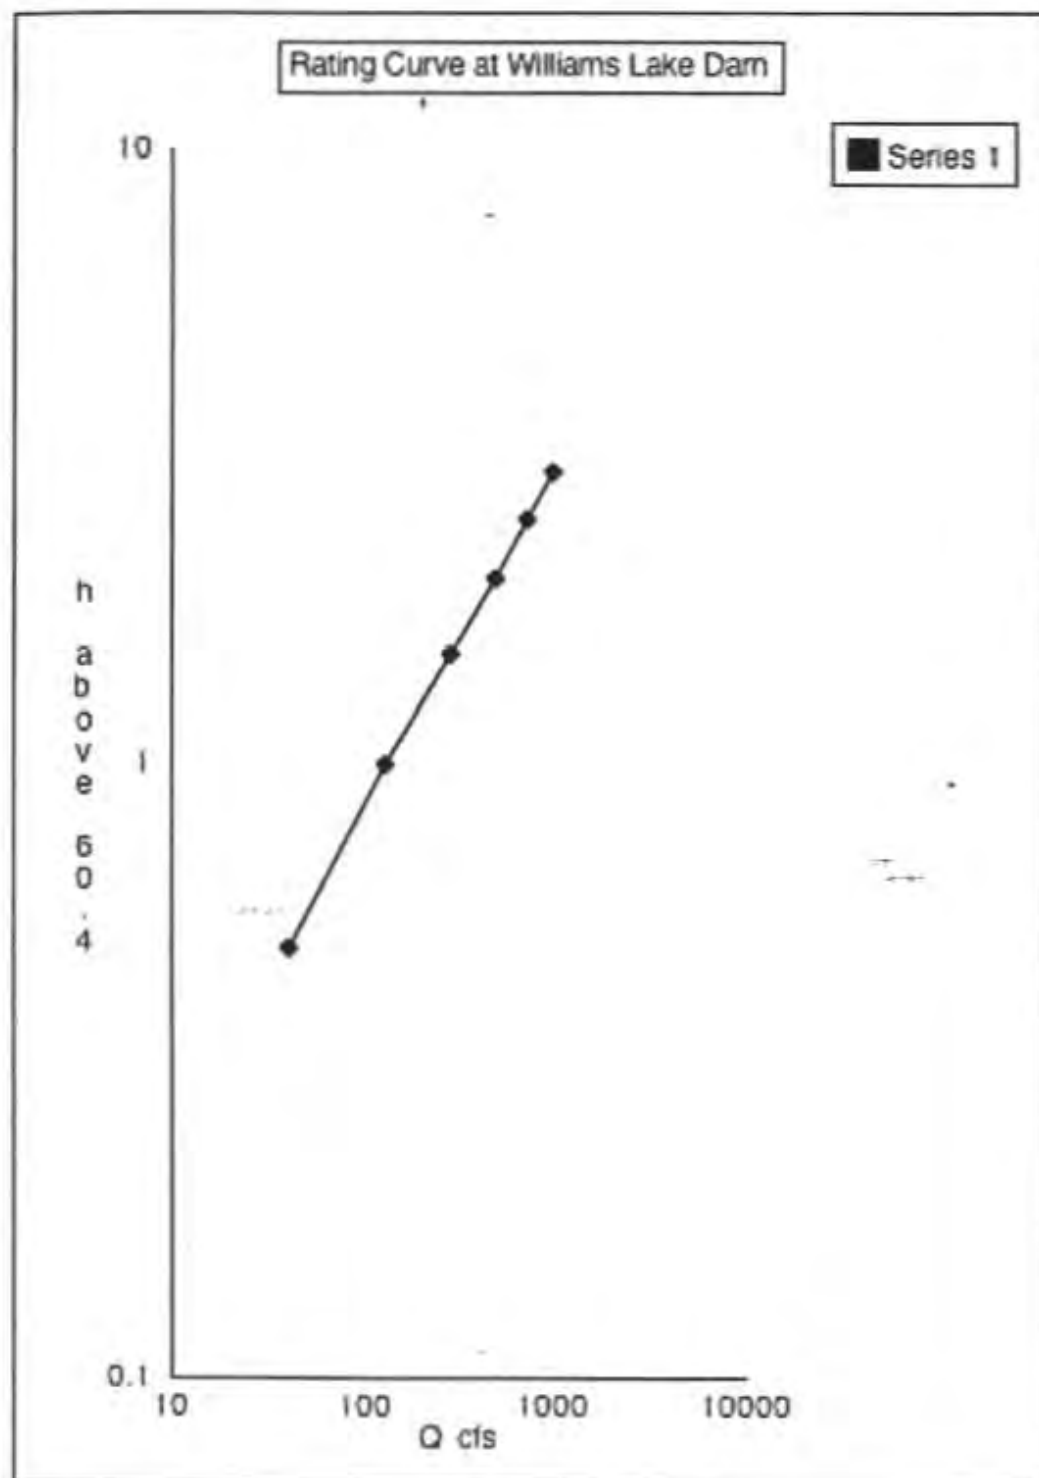
The rating curve developed for the outlet cross section flows:

This rating curve was calculated incrementally, assuming the same cross section through the dam/embankment, but adding the contribution of each rise in stage to the flow, using the formula:

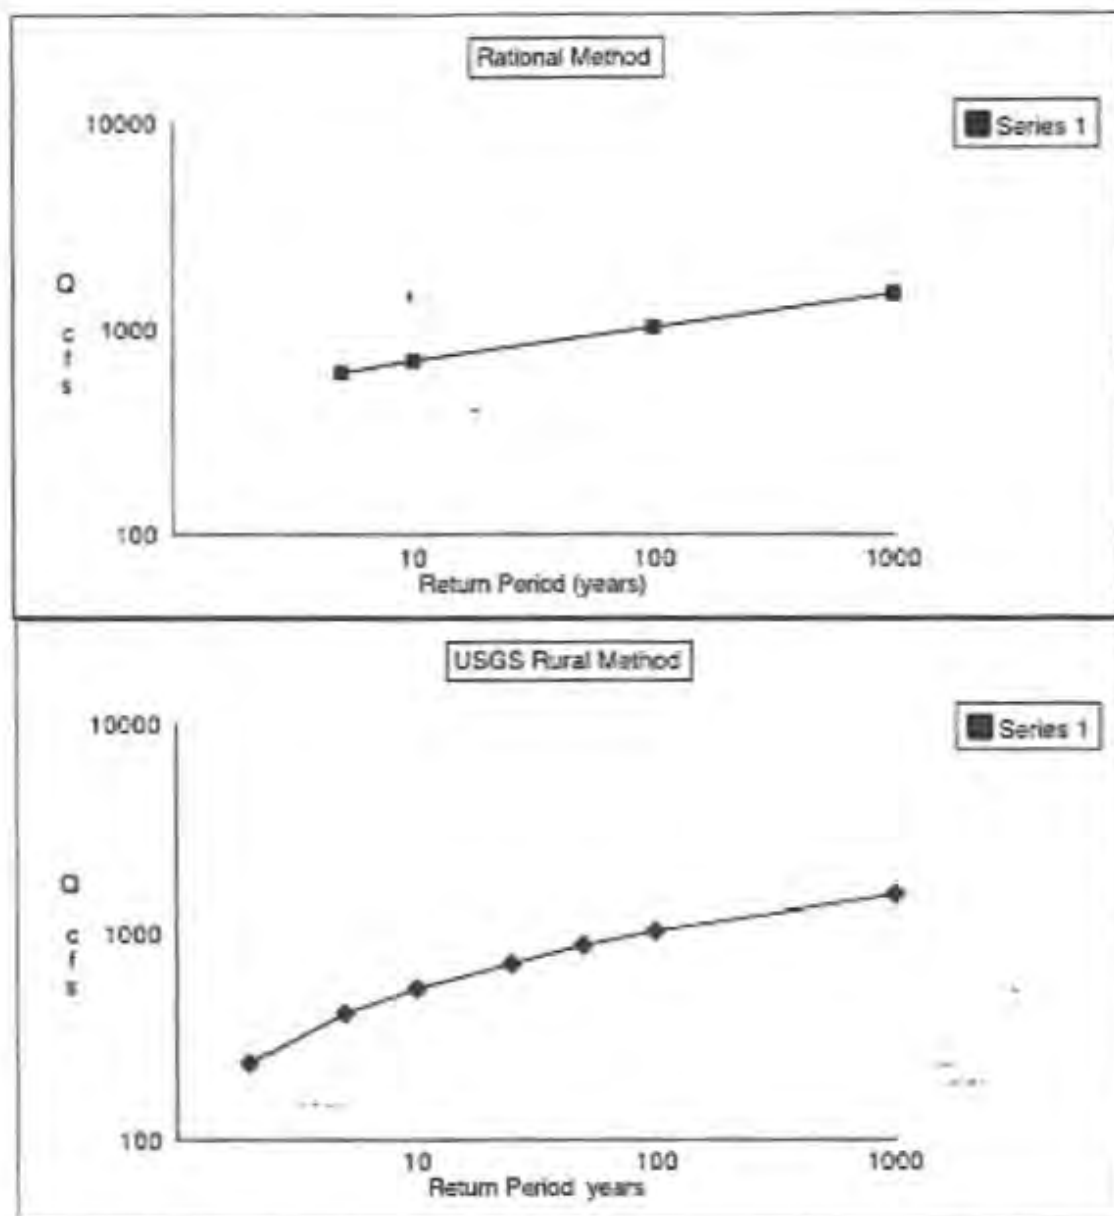
The results of the two methods were strikingly similar, and are compared on the following charts.

The flows for the 1000 year return period storm have been graphically extended on these charts, and both arrive at 1500 cfs.

These flows are large. The 100 year peak flow from the Rational Method is 1020 cfs, or 382,000 gallons per minute. The flow from the USGS method is essentially identical.

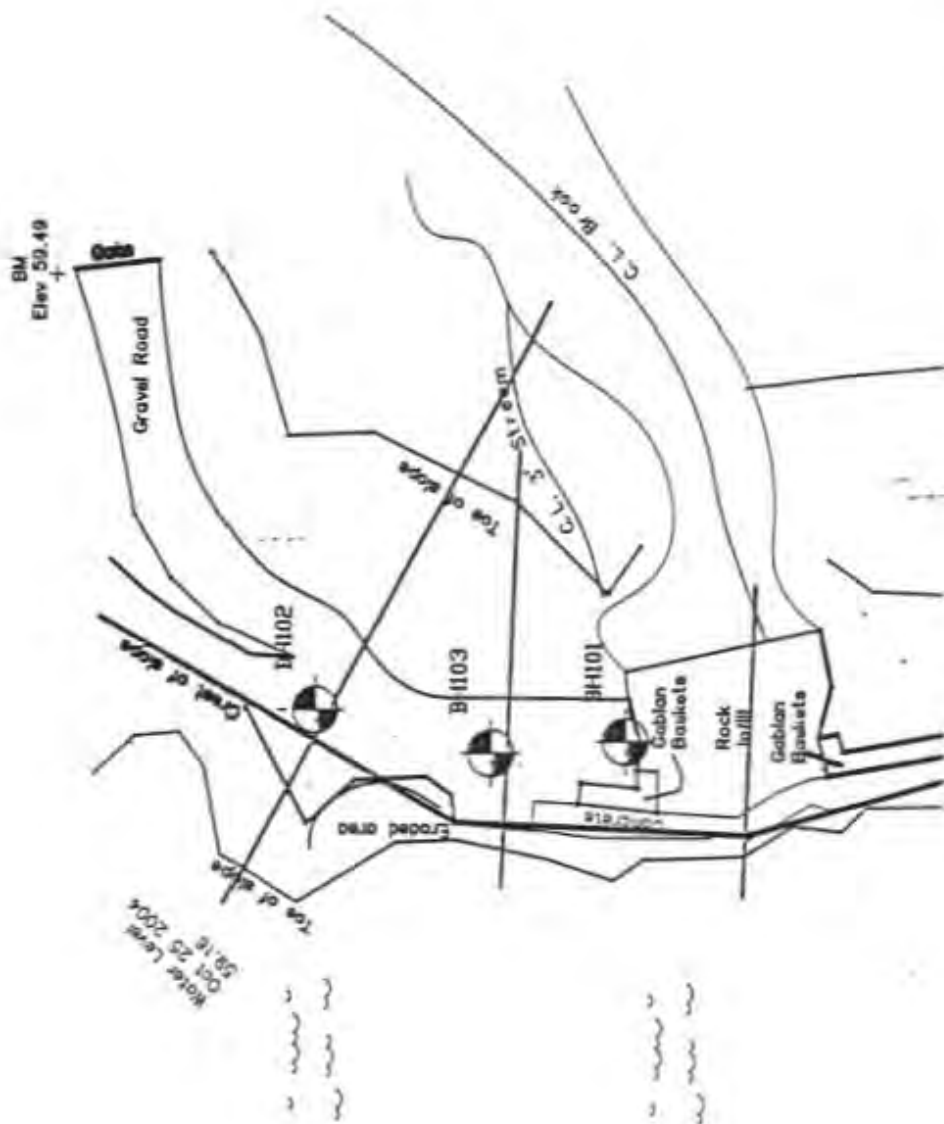
**Borehole Logs BH101, BH102, BH103**

Based on observations during the investigation, bedrock depth was noted in all borehole locations. Depth to bedrock varied from 0.47 m to 2.79 m below ground surface at BH102 and BH101, respectively. Bedrock observed at both boreholes was a bluish gray, medium grained metasandstone of the Halifax Formation. It is qualitatively assessed as medium strong with close joint spacing.

Water levels were observed on October 27<sup>th</sup>, 2004. BH101, with the monitoring zone between 3.7 m and 1.2 m below ground surface, had a water level of 0.9 m below ground surface. BH102, with the monitoring zone between 2.79 m and 0.6 m below ground surface, had a water level of 1.5 m below ground surface. At the time of the water level readings, the lake level was approximately 0.4 m below the same ground surface.
